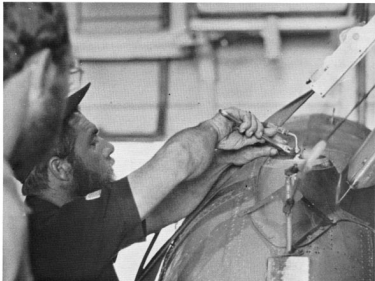
Maintaining aircraft is a "tight situation" for AD1 Turley
